Application: As an additive package to motor oil and fuel in 1,800 Horse Power diesel engine driving 1000 KVA CUMMINS electrical generator: anti-wear protection and reduction in fuel and oil consumption during normal operation.

User: Asphalt Quarry

Application: As an additive to motor oil in diesel engine in 800 KVA CUMMINS electrical generator: anti-wear protection during regular operation.

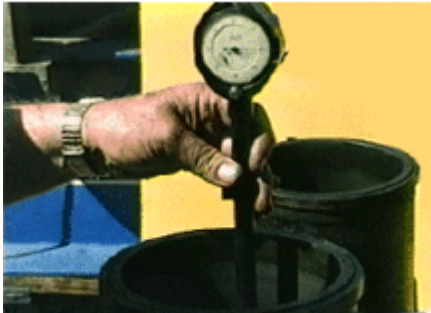
All the liners were micro-measured. There was no wear whatsoever, all the dimensions were within the manufacture's specs of a new engine.

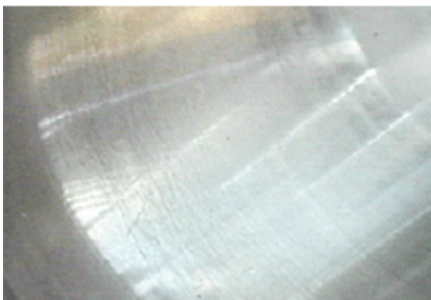
In all the liners, you could see distinct traces of the cross-honing pattern of the original bore and the liner surfaces looked polished and shiny.

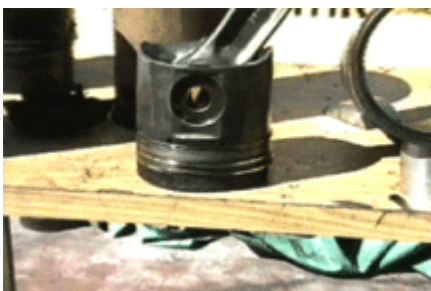
All the pistons had piston-skirts and piston rings completely clean of any build-up. The rings looked like new and did not have any wear whatsoever (very unusual phenomenon, taking into consideration that the engine was in service for 30,000 hours and had water in its oil system for more than 100 hours.)

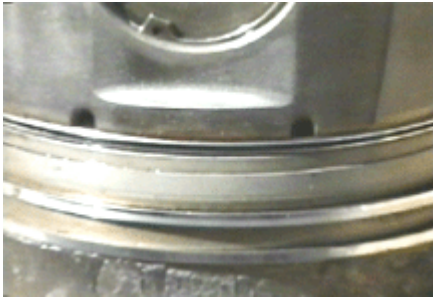
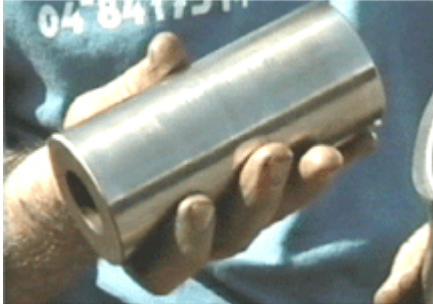
After 30,000 hours in operation and 100 hours in the presence of water, no piston pins had any traces of wear, looked shiny and new.

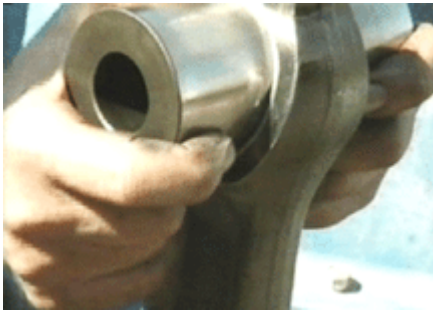
Usually, after 17,000 hours in operation there are extensive clearances between the piston pin and piston-pin bearing. In this case, there were no clearances at all in spite of the fact that the engine was in service for 30,000 hours and had water in its oil system for 100 hours while in operation.

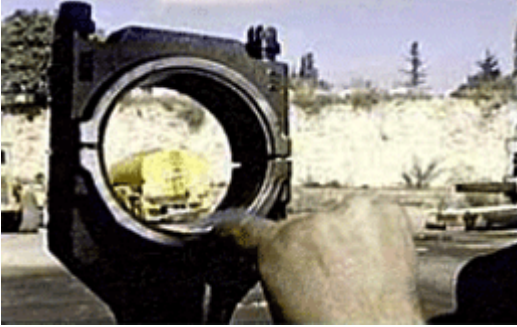
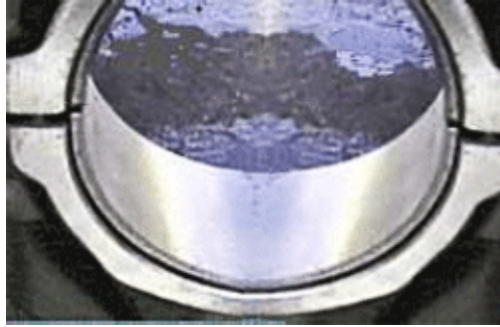
Piston-rod-bearing housing is completely clean of any deposit build-up. The bearing itself is clean of any scoring or scuffing, has its original thickness and its surface looks highly polished.

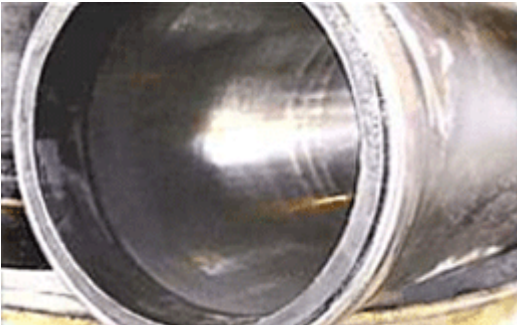
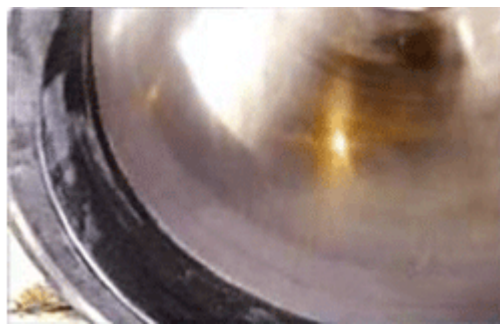
Cylinder sleeve, completely clean with no deposit build-ups. In most of the sleeves, there were traces of cross honing of the original bore, meaning almost no wear took place. The sleeve walls were highly polished.

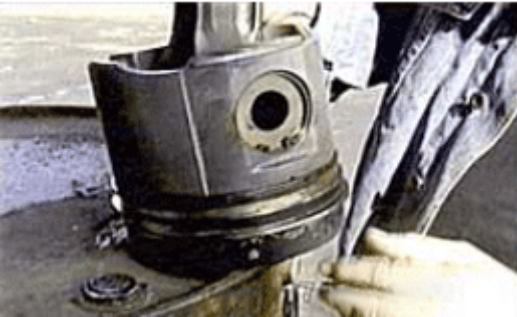
The piston-skirt and piston rings are completely clean of any deposit build-ups, and the piston ring-blades are highly polished (virtually no signs of wear). The build-up you see on the piston top, which is due to deposits from burnt fuel in combustion chamber, could be eliminated by using Bi-Tron Fuel Conditioner.

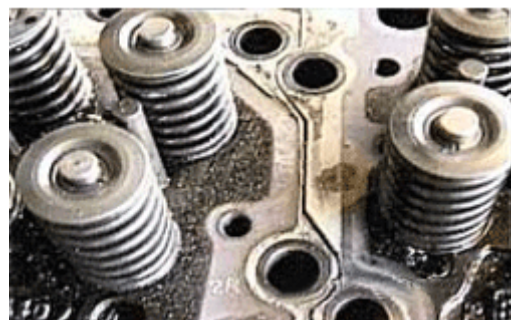
The oil baths, valve springs, valve stems and the block surface are completely clean of any deposit build-up.
